Project Overview and Need

Topographical Survey

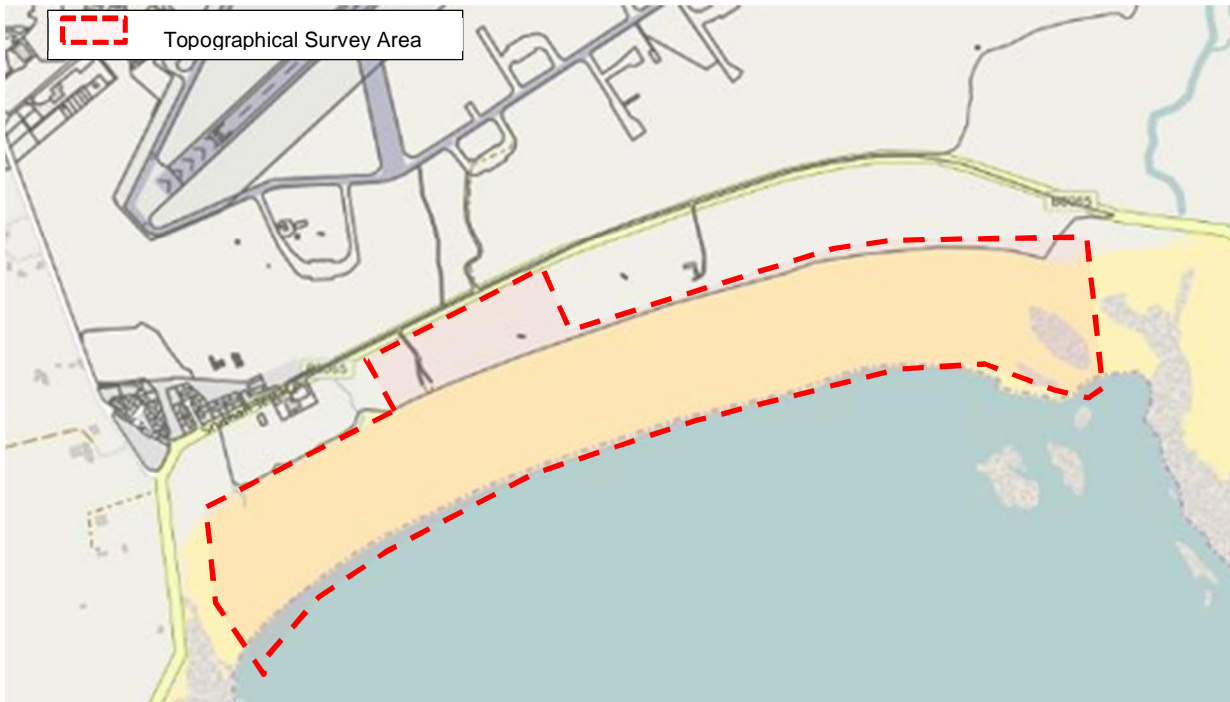
Figure 1 – Topographical Survey Area

This will be conducted by a 3 person team commencing in November 2021 (exact date tbc). The team will set up a temporary base station and will traverse the sand dunes and beach foreshore on foot as shown in Figure 1. They will be using portable equipment to record ground levels and notable features. The works will take circa 2 weeks to complete and due to tide times, some of these works may be completed at dawn and dusk using head torches. Please do not disturb the base station as this will mean the survey will need to be repeated.

As part of the Coastal Protection works on Tràigh Bhàigh, HIAL have commissioned a topographical survey along the full length of the beach from the crest of the dunes to the Low Water Mark to obtain georeferenced level data and beach profiles.

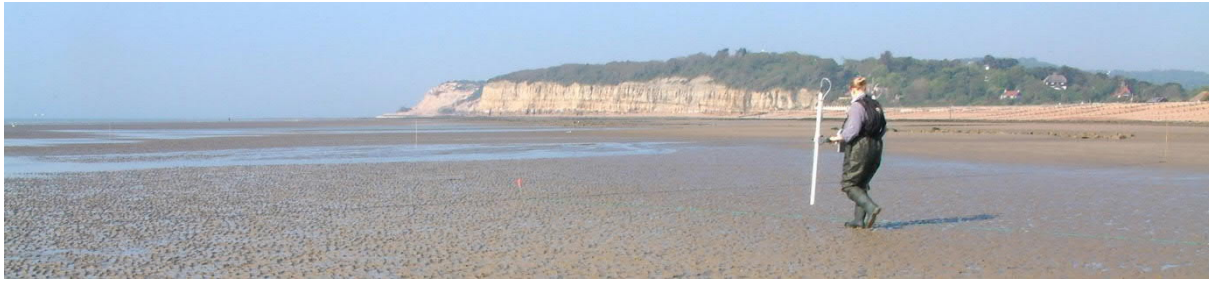
Electro-magnetometer Survey

These works will also be conducted by a 3 person team commencing in November 2021 (exact date tbc). The team will traverse the sand dune area on foot, using equipment that detects variations in the conductivity and magnetism of the underlying ground. These variations will be interpreted to identify areas with different material properties that can be correlated with buried wastes and sands etc. The works will take between 2 and 3 weeks to complete.

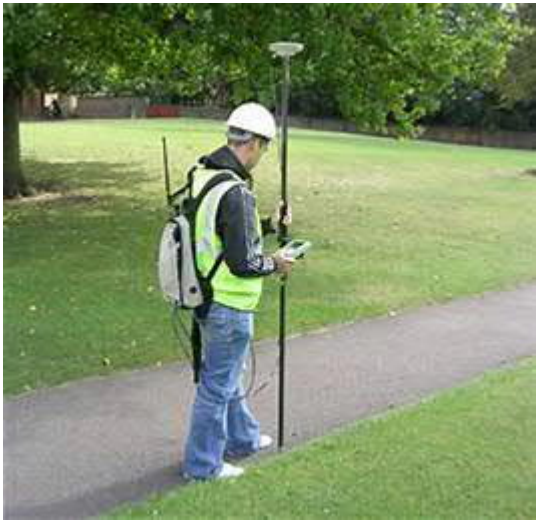
Hand Held GPS Receiver

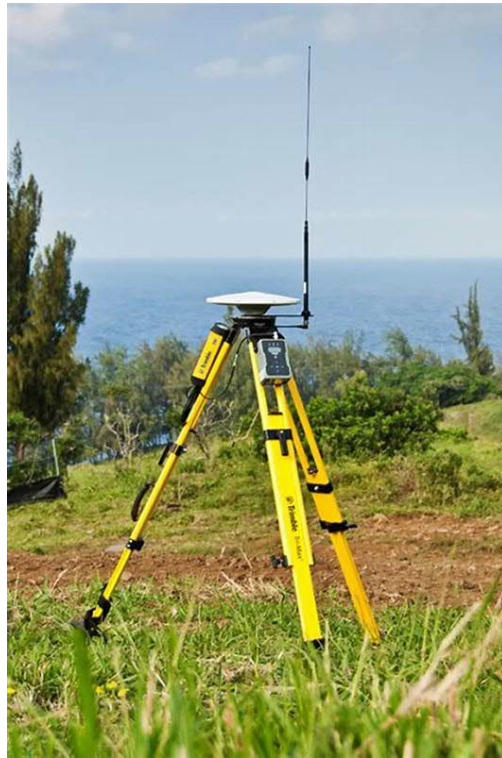
GPS Base Station
